# FINAL REPORT INVESTIGATION OF SMOOTH-BONDED METAL LINERS FOR GLASS FIBER FILAMENT-WOUND PRESSURE VESSELS

by J.M. Toth, Jr. and D.J. Soltysiak

Prepared for NATIONAL AERONAUTICS AND SPACE ADMINISTRATION May 1967 CONTRACT NAS 3-6293

NASA CR-72165 DOUGLAS REPORT DAC-60640

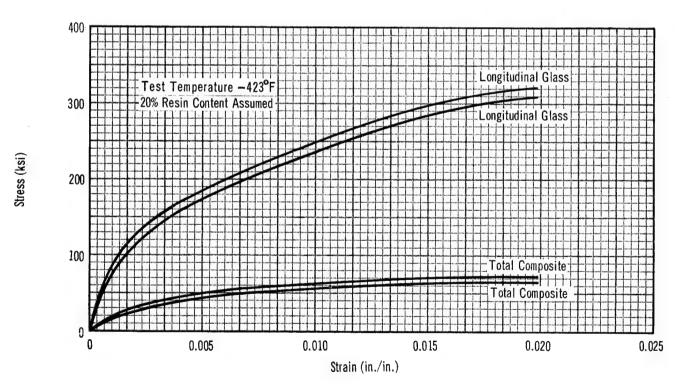
Figure 23. Stress-Strain Diagram, - 7 1/2-in.-Diam Vessel D1

Development vessel Dl was pressure tested at a temperature of -423°F. The vessel attained a maximum hoop strain of 2.1% at an internal pressure of 569 psi, at which time the vessel leaked excessively. Stress-strain curves for the vessel are given in figure 23. The desired objective of hoop to longitudinal strain ratio of 1/1 in the test section was achieved.

The internal pressure was applied to the vessel at a rate to cause a strain of approximately 1%/min. to 130 psi. At this point, all vacuum was lost in the chamber. The internal pressure was increased to a maximum of 569 psi at a rate which caused the vessel to strain approximately 4%/min. The vessel did not burst.

A post-test ambient leak check of the vessel at 20 psi showed leakage in the longitudinal doubler area. A small delamination (1/4 x 1/2 in.) was found in the area which exhibited the leakage observed in the ambient leak check. The aluminum liner in the cylindrical section, except for the area of the internal longitudinal doubler, appeared to be completely bonded. There were no apparent voids or delaminations. The bond line between the doubler and the liner contained voids. In some cases, liquid was probably forced behind the doubler into the void areas and upon release of pressure, the pressure differential caused a balloon effect. Doublers had been used in both the longitudinal and circumferential joints.

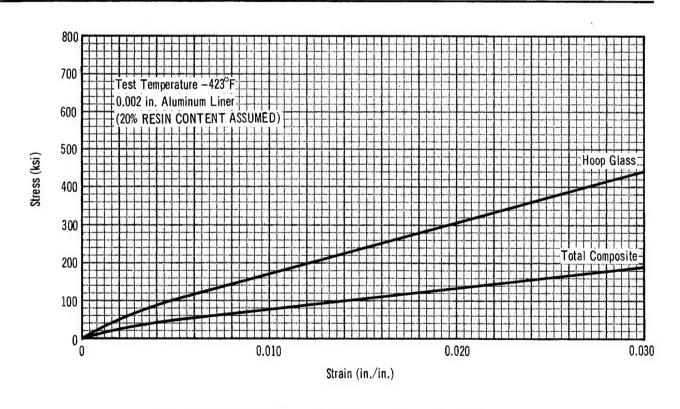
Figure 24. Hoop Stress-Strain Diagram - Vessel D2

The fiberglass lay-up was identical to that of vessel Dl, except that the flange was fabricated with preimpregnated glass cloth. The vessel was tested at -423°F. Maximum pressure reached 815 psia. Excessive leakage through the liner doubler-joint and/or end seal prevented continued pressurization. A maximum hoop strain of 3% was attained. The stress-strain curve is shown in figure 24.

The two biaxial strain gages did not stay bonded to the aluminum liner. One fell off during chilldown and the second fell off very early (at less than 50-psi internal pressure) during the pressurization. The aluminum liner had been sand-blasted in the installation area before strain gage installation.

Post-test inspection revealed that the liner in all but the longitudinal doubler area looked excellent. There were no cracks, wrinkles, or buckles. The circumferential doublers appeared satisfactory. There were some voids that appeared as indentations but no cracks, bubbles or debonding.

In the seal area at the inner edge of the backup ring, cracking of the foil occurred. At one end there were two cracks, one was 3/4-in. long and the other was 1/4-in. long. At the other end there was one crack 3/4-in. long. The longitudinal doubler contained voids that appeared as delaminations and bubbles in the test section, particularly along the edges (fig. 25). Cracking of the doubler occurred in some of the delaminated buckled areas.

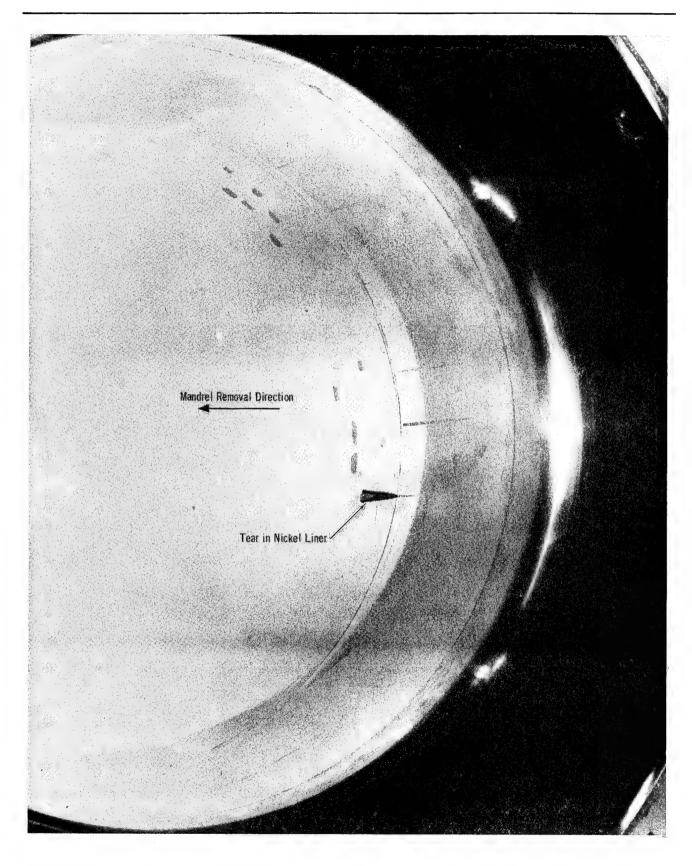
Figure 29. Vessel TN-1, Tear in Nickel Liner

Removal of the mandrel following vessel cure was extremely difficult. The procedure that proved successful was to wrap the vessel with heating tape, and chill the mandrel interior with dry ice. During mandrel removal, the liner was torn for a distance of approximately l-in. long by 1/2-in. wide, at a point where the deposition had bonded to the stainless steel mandrel (fig. 29). The liner tear was repaired with aluminum foil overlay.

Lockheed personnel indicated that future vessel removal could be guaranteed. Obviously, the passivation of the mandrel surface had not been complete with the development liners. Future passivation processing could include a chromic acid immersion, nitric acid immersion, and hot water rinse.

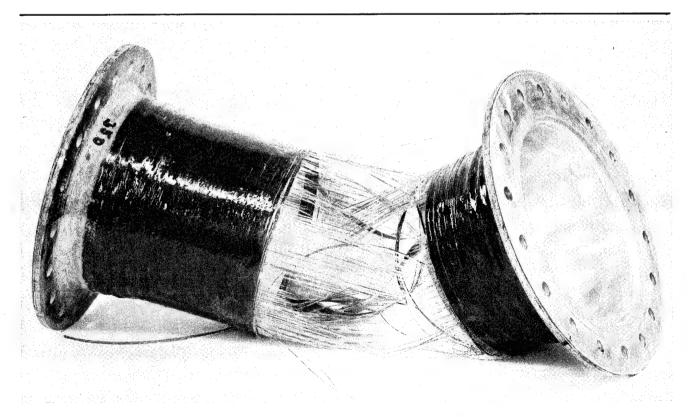
Figure 33. Vessel TA-1-Post-Test, General View

Vessel TA-1: This vessel was tested at -423°F. It failed at a pressure of 711 psi.

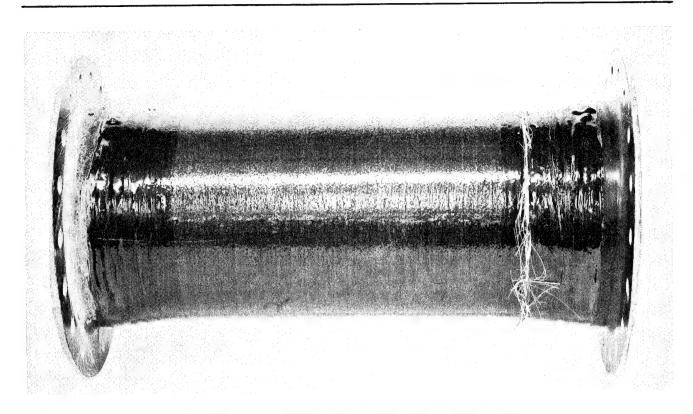
Figure 35. Vessel TA-2-Post-Test Overall View

The vessel failed on the initial intended cycle to 550 psi at 403 psi.

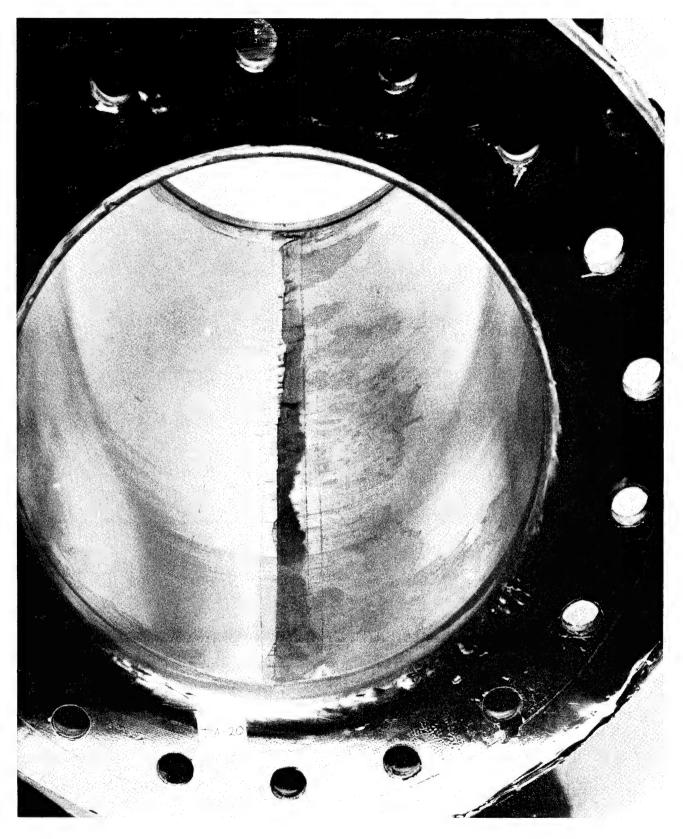
Figure 44. Vessel TA-20, Longitudinal Seam Deformation

Post-test examination of the vessel indicated a leak in the liner at the sealed leakage area. This is the area which had leaked during the ambient temperature test and had then been repaired.
